DEPARTMENT OF NATURAL RESOURCES
DIVISION OF OIL, GAS AND MINING

INSPECTION REPORT

Mine Name: Cloudy Moon Number: S/037/116 County: San Juan Status: Active

ATTACHMENT
Inspection Date: March 27, 2003; Report Date: April 3, 2003
Photographs
S/037/116, Cloudy Moon Quarry, Moon Mountain Stone

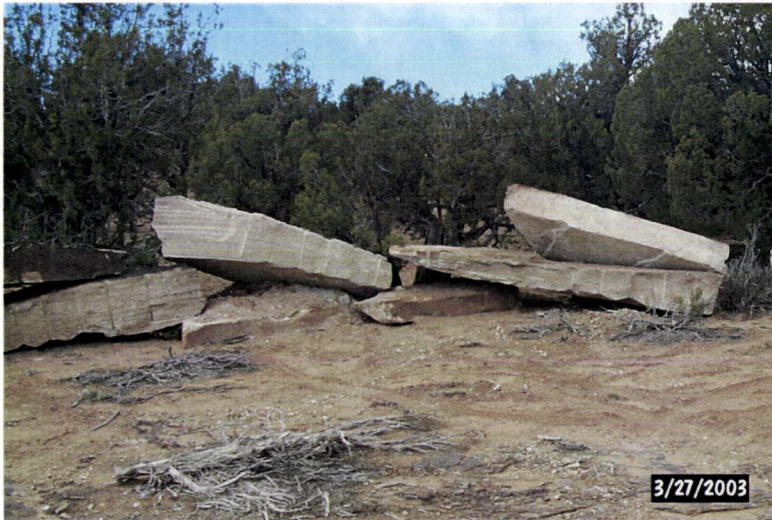
The quarry is in two areas on the east and west sides of a point. On the east side, it appears the operator has been splitting large stones on the surface rather than digging them (Photo 1). Surface disturbance is minimal. There is a road that has been graded to this area.

Photo 1. Some of the split stones at the east quarry.

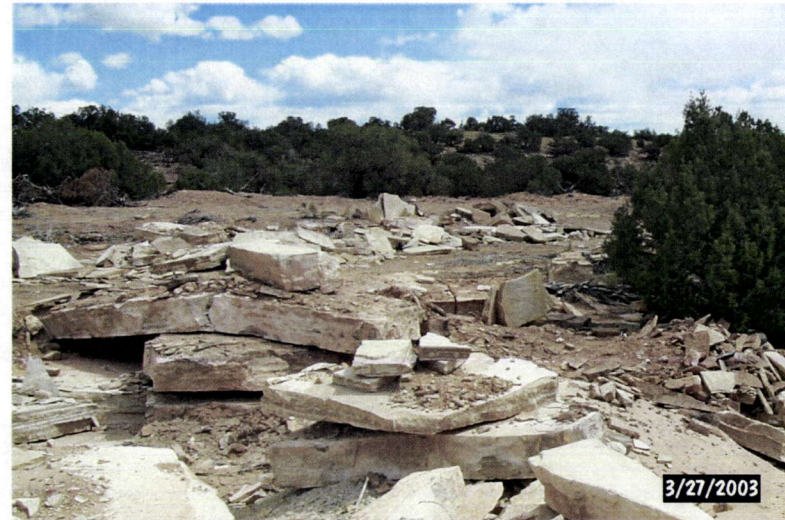
There is more of a traditional quarry on the west side, and it appears the operator has been using a forklift to lift stone out of the ground (Photos 2-4). There was a forklift on site although I'm not certain it is operable.

Photo 3. Another photo of the west quarry area.

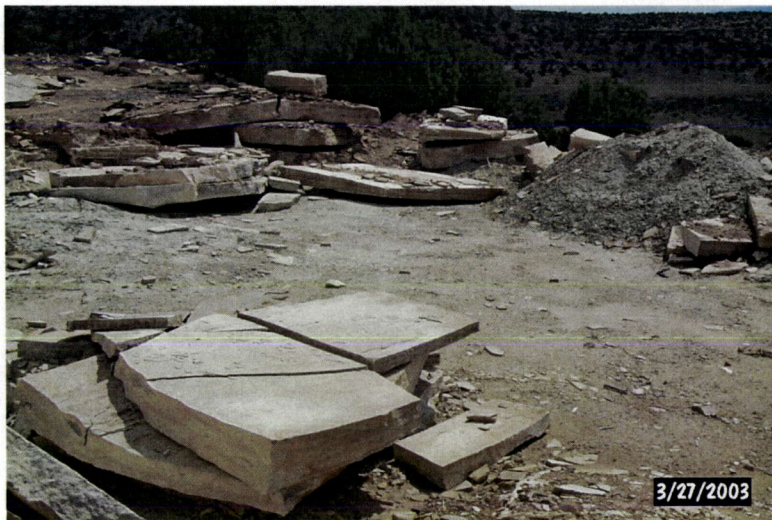
As far as I am aware, this site had not been previously disturbed. In the west quarry, there is not a lot of soil over the stone, but it looked like there was enough that it could be salvaged. We did not see any soil stockpiles. The operator needs to begin salvaging soil in this area.

Photo 2. West quarry area.

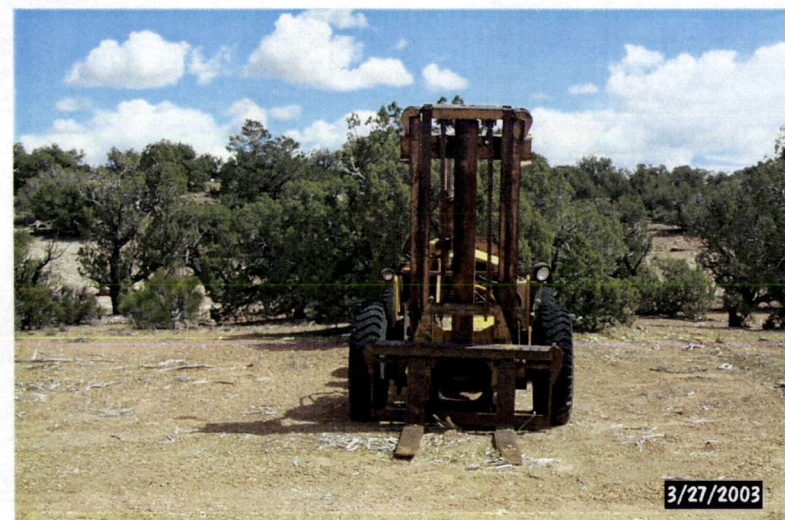
Photo 4. Forklift at the west quarry.
